Manhole Inspection Summary

Manhole # S17I__004MH

Insp Date: **2/27/08 11:41 AM**

Location Address: **2500 lombard st**

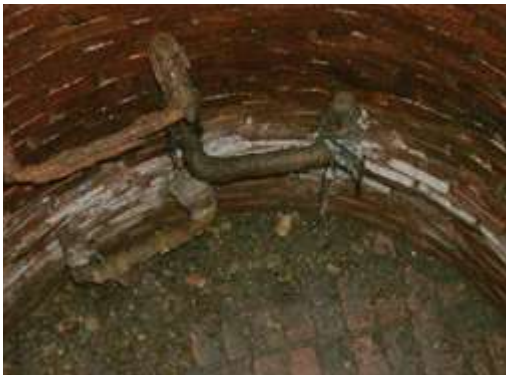
Defect 3

Surcharge ☒ **Evidence Of Surcharge** Depth: **3** (ft.) ☐ Active Surcharge Present

surcharge evidence on the steps

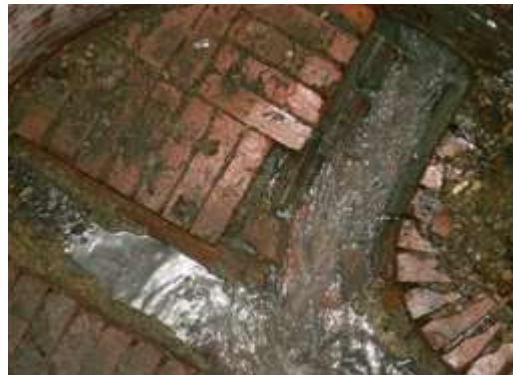
Defect 2

Condition: ☐ Sound ☐ Cracked ☐ Root Intrusion ☒ **Deteriorated** ☐ Leaks ☐ Debris

deteriorated bench

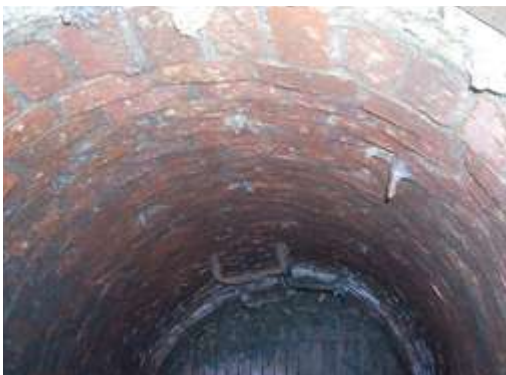
Defect 1

Steps Count: **3** Missing: **3** ☒ **Corroded**

corroded and missing steps

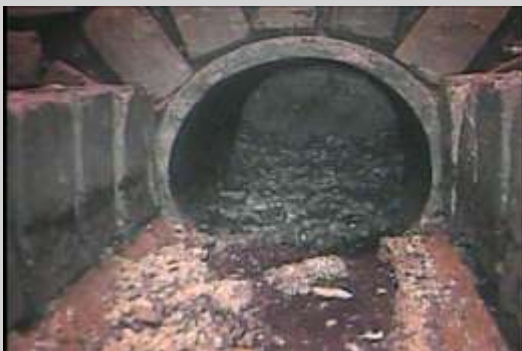
6 O'Clock Inflow

abandoned

Pipe Height: **7.2** (in.) Rod and Bar (Angled)
Pipe Material: **Clay** ☐ Pipe Lined
Invert Depth: **10.29** (ft.) Flow Characteristics: **None**
Deposits: ☐ None ☒ **Mud** ☐ Sludge ☐ Debris ☐ Grease
Silt Depth: **1** (in.) Deposits Extent: **Light**
Infiltration: **None** Pipe Seal Cond: **Sound**

Connects To: **Stub connection / abandoned**

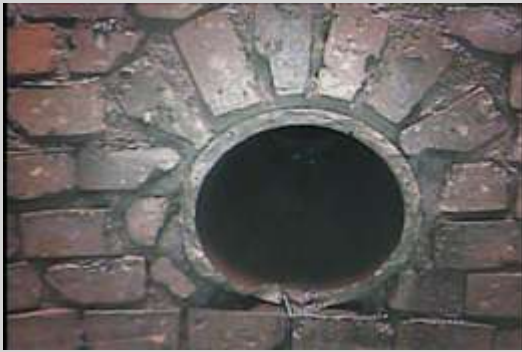
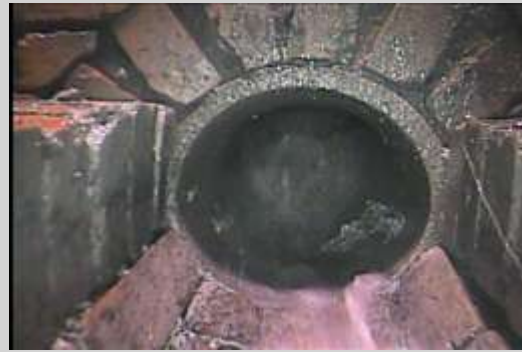
9 O'Clock Inflow

Infiltration: **None** Pipe Seal Cond: **Broken**

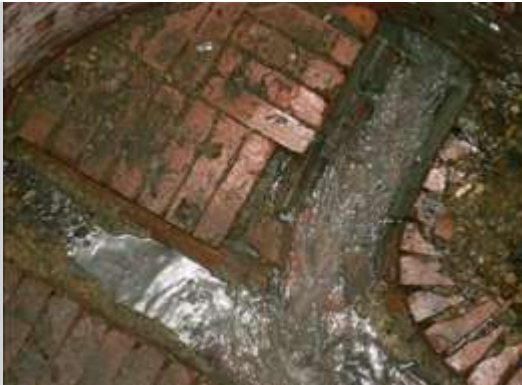
Defect 2

deteriorated bench
